Construction Observation

DISTRIBUTI	LLJ
PROJECT	Lincoln Park Zoo Pavilion	REPORT #	2		
LOCATIO	Chicago, Illinois	TRIP DATE	September 24, 2020		
PROJECT	_	ENGINEER/OB	Dave Eckmann		
CLIENT	Studio Gang Architects	TODAY'S DATE	11/5/2020		
CONTRA	Pepper Construction	PAGE	1 OF 11

Purpose: Site visit with Harry Soenksen of Studio Gang to observe the condition of the pavilion and provide recommendations on improving current conditions and future maintenance.

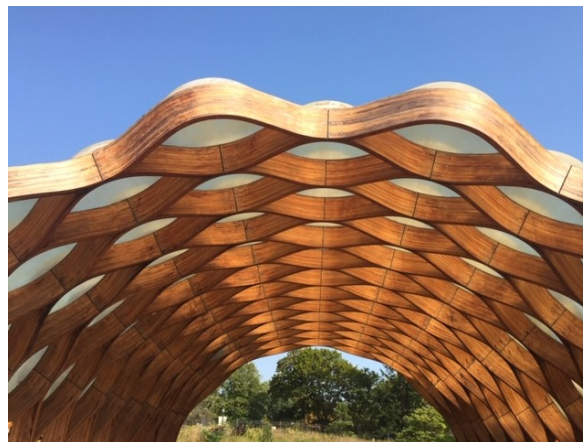
1. New oil has been applied to the full structure as seen in **Figure 2**. MKA's understanding is that the oil application followed the Wood Preservation Plan for Lincoln Park Shelter dated 11/8/19 by Autumn Peterson, CEO of Heritage Natural Finishes.

Figure 2. New Oil on Pavilion (Photo of South Side)

Recommendation: Additional coats of oil should be applied, especially on south-facing surfaces, to ensure that timber absorbs as much oil as possible and surfaces are uniformly coated/protected. MKA suggests that SGA provides a follow-up inspection after all oiling is considered complete. Heritage may also recommend a wax and UV coating on the south faces.

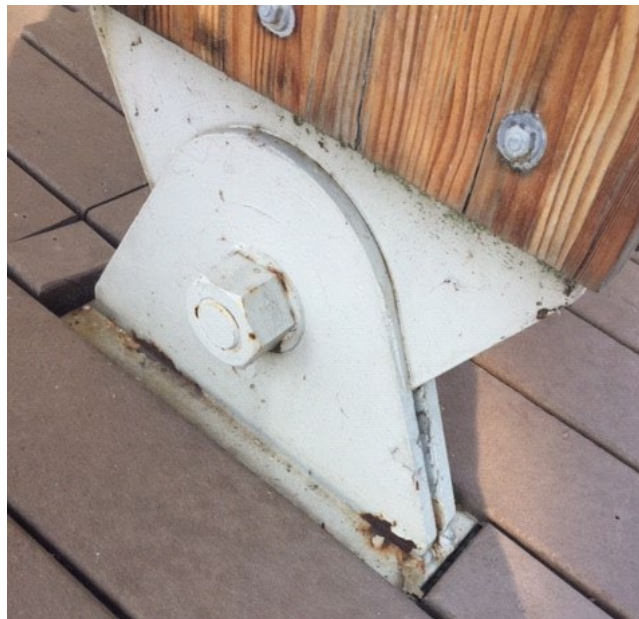
2. Visible rust on steel base connections was observed in most locations as shown in **Figure 3**.

Figure 3. Visible Rust at Steel Base Connection

Recommendation: Clean any metal surface to be painted using a wire brush to remove loose rust and paint. Where bare metal is exposed, use rust preventative epoxy primer. Once all bare metal locations are primed, apply an automotive finish paint over the entire metal surface. <https://www.martinsenour-autopaint.com/rustproof/specialty/rustproof-md-gloss-dark-gray>

Thru-bolts at all base connections should be tightened prior to painting.

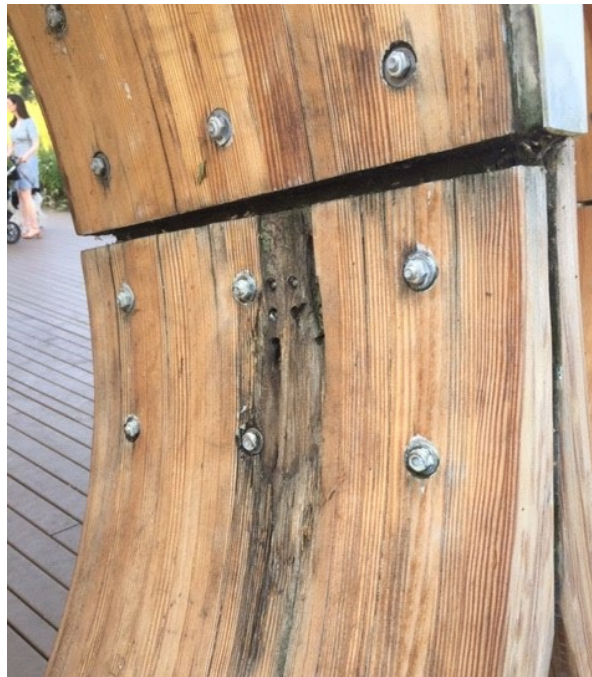
3. In a few locations, but especially at Grid C (east), the outer lamination of the timber has “spalled” - likely due to moisture intrusion in the end-grain near the connections, and pins on the hidden connection plate are exposed (see **Figure 4**).

Figure 4. Wood Spalling at Grid C – East

Recommendation: Sand areas to remove dirt and debris. At exposed pins, fill any gaps with wood filler (see product recommendation below) to help protect the pins from corrosion. Two options for repair are listed below. Option 1 is recommended for aesthetics and to achieve more uniform weathering over time with adjacent timber material. After repair, re-apply Heritage oil as recommended by Heritage Natural Finishes.

Option 1: Patch spalled area with new glulam material (glued and screwed thin veneers). Recommend contacting Rick Collins of Trillium Dell Timberworks – rick@trilliumdell.com - or a similar contractor. Added screws can be hidden with wood filler.

Option 2: Patch area with wood filler – recommend using Abatron WoodEpoxy or equivalent.

Option 3: Replacement - A long term solution would be replacement of the member. It is possible to remove and replace the member without compromising the structure. If this route is selected please contact SGA, MKA and Trillium Dell for further coordination.

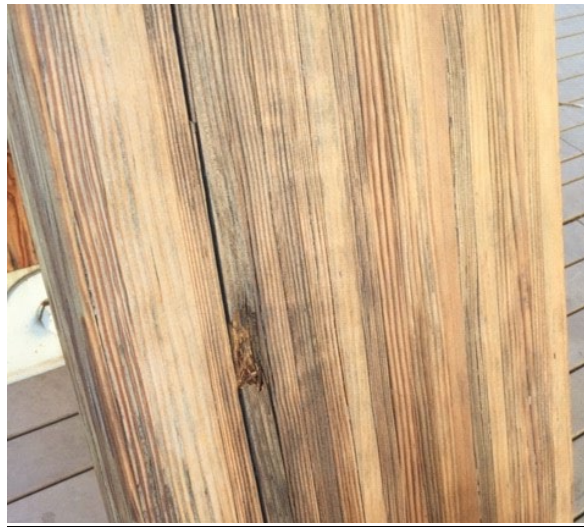
4. A similar timber-spalling condition can be found away from the connections, shown in **Figure 5**, which occurs near the base at Grid C-west.

Figure 5. Wood Spalling at Grid C – West

Recommendation: Sand areas to remove dirt and debris. Follow Option 1 or 2 listed above for repairing. Re-apply Heritage oil as recommended by Heritage Natural Finishes.

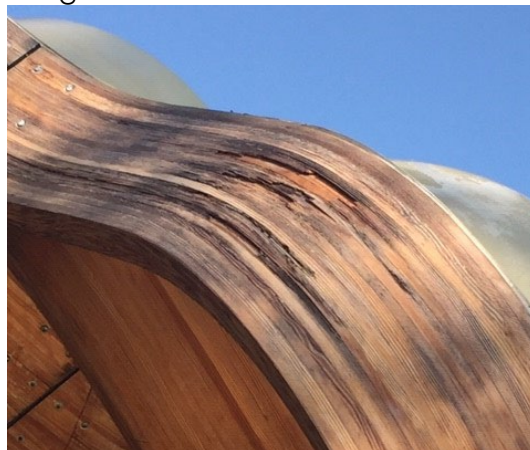
5. The worst wood spalling occurring away from the connections was observed along the south side of the pavilion (see **Figure 6**). This is likely due to the additional exposure to weather typically seen for south-facing conditions.

Figure 6. Wood Spalling at Southside (Southeast)

Recommendation: Sand areas to remove dirt and debris. Remove all wood showing signs of rot or decay. Do not remove more than $\frac{3}{4}$ " of thickness from the original surface. Wood filler or epoxy is not recommended for this area given the extent of spalling. Instead, patch spalled area with new glulam material (glued and screwed thin veneers). Recommend contacting Rick Collins of Trillium Dell Timberworks – rick@trilliumdell.com - or a similar contractor. Added screws can be hidden with wood filler. Re-apply Heritage oil as recommended by Heritage Natural Finishes.

Option 2: Replacement - A long term solution would be replacement of the member. It is possible to remove and replace the member without compromising the structure. If this route is selected please contact SGA, MKA and Trillium Dell for further coordination.

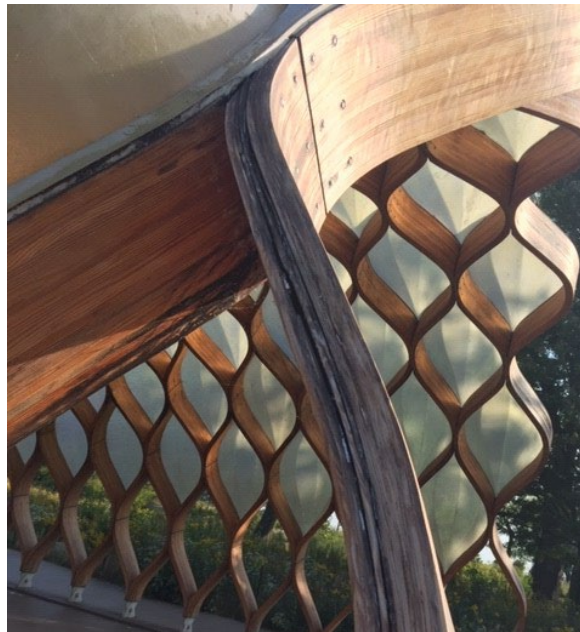
6. There are several areas, particularly along the west side, where some delamination has occurred along the narrow face of the timber member (see **Figure 7**).

Figure 7. Delamination Along West Side

Recommendation: Sand areas to remove dirt and debris. Two options for repair are listed below. Option 1 is recommended for aesthetics and performance over time. After repair, re-apply Heritage oil as recommended by Heritage Natural Finishes.

Option 1: Clamp laminations together with screws. Recommend contacting Rick Collins of Trillium Dell Timberworks – rick@trilliumdell.com - or a similar contractor. Added screws can be hidden with wood filler.

Option 2: Patch area with wood filler – recommend using Abatron WoodEpoxy or equivalent.

Option 3: Replacement - A long term solution would be replacement of the member. It is possible to remove and replace the member without compromising the structure. If this route is selected please contact SGA, MKA and Trillium Dell for further coordination.

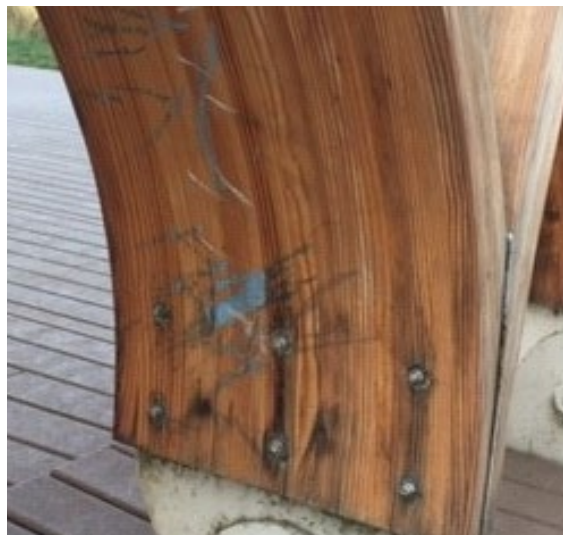
7. In a few locations, graffiti and carvings were observed (see **Figure 8** which is located at Grid E-East).

Figure 8. Graffiti and Carving Near Base Connection

Recommendation: Sand areas to remove dirt and debris. Continue sanding to remove graffiti and carvings and re-apply Heritage oil as recommended by Heritage Natural Finishes.

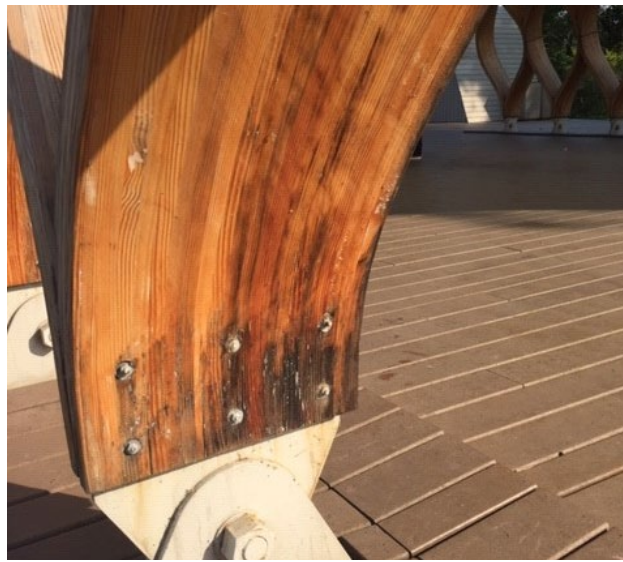
8. Some dark staining was observed in several areas, likely caused by soiled water from rain or snow (see **Figure 9** which is located at Grid J - West). Where tested by hand on site, the wood appears solid and not spongy, suggesting no signs of rot or decay.

Figure 9. Dark staining at Grid J-West

Recommendation: If aesthetically desired, sand areas to remove dark staining and re-apply Heritage oil as recommended by Heritage Natural Finishes.

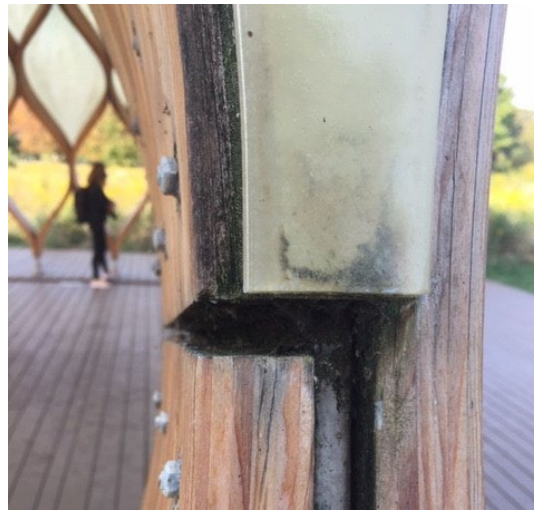
9. In most joints near the base, installed chinking does not extend to the edge of the timber members (see **Figure 10**). There also appears to be some deterioration of the member end-grains given the susceptibility of collecting moisture on these surfaces.

Figure 10. Chinking in Connection Joints

Recommendation: Remove existing chinking. Clean and sand joint. Apply wax-based end-grain sealer (suggest using Heritage Liquid Wax End Sealer or similar) and install new chinking to cover the full surface area of the member end-grain.

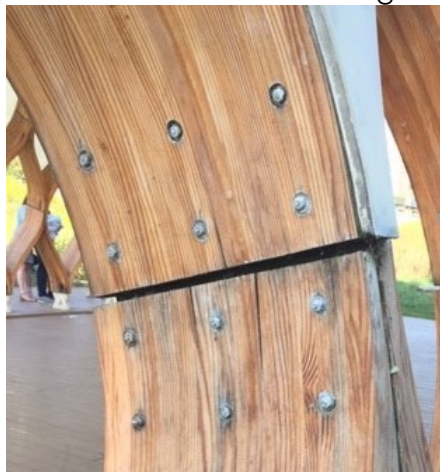
10. In some locations, thru-bolts appeared to be loose or missing washers (see **Figure 11**)

Figure 11. Thru-bolts at Typical Connections

Recommendation: All thru-bolts should be inspected and re-tightened after oiling and repairs are complete. Any damaged thru-bolts or thru-bolts missing washers should be replaced with stainless steel $\frac{1}{4}$ " diameter thru-bolts.

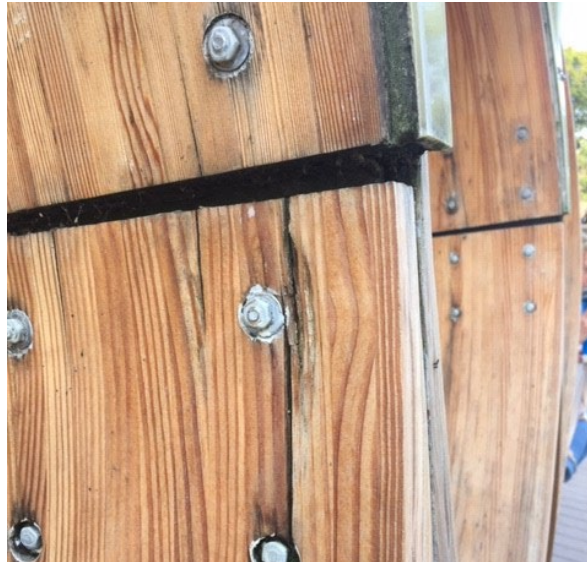
11. In a few locations, timber splitting was observed at the connections (see **Figure 12** taken at Grid D - East).

Figure 12. Splitting at Connections

Recommendation: Cracks such as these, in the wide faces of members, can be left as shown but should be monitored to make sure they do not enlarge. Other options to mitigate are listed below. Option 1 is recommended for better long-term performance.

Option 1: Apply screws to clamp cracks together, similar to the recommendations listed above for cracks found in the narrow face of members.

Option 2: Patch area with wood filler – recommend using Abatron WoodEpoxy or equivalent.

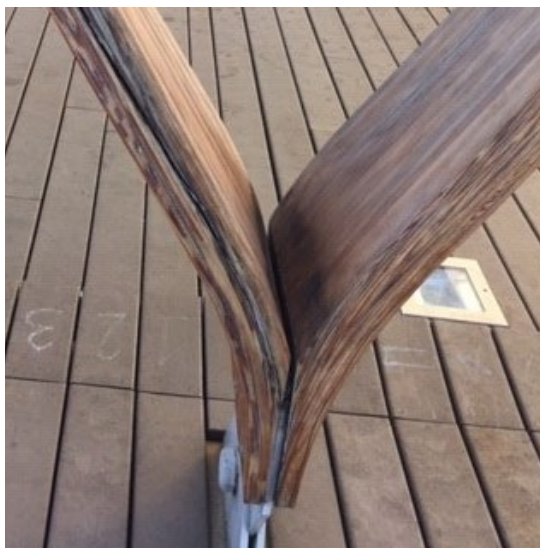
12. In all base conditions, it appears as if chinking was not installed or needs to be replaced in the joint between glulam members at the base connections (see **Figure 13**).

Figure 13. Missing Chinking at Base Connections

Recommendation: Sand and clean area and install or replace chinking.
